DEGRADATION OF COATING ALLOYS  
IN SIMULATED MARINE ENVIRONMENTS

R.H. Barkalow and F.S. Pettit  
Pratt & Whitney Aircraft Division  
United Technologies Corporation  
400 Main Street  
East Hartford, Connecticut 06108

15 June 1978

Final Report: 1 March 1976 to 1 March 1978

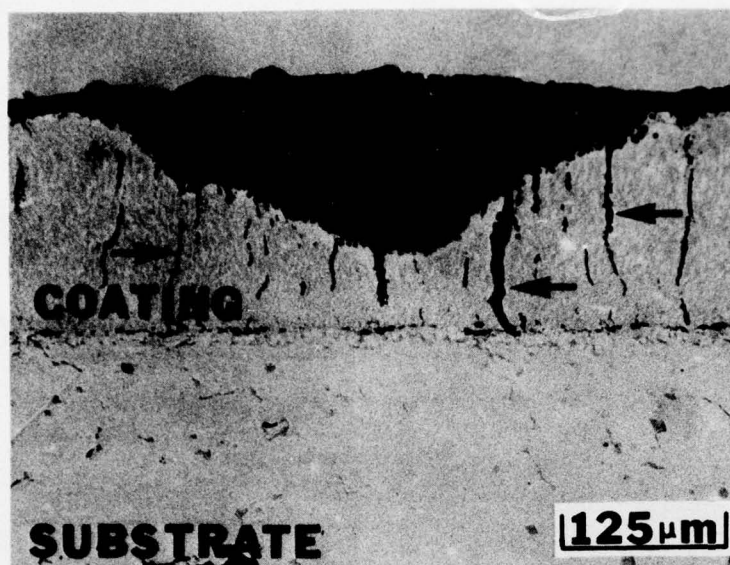
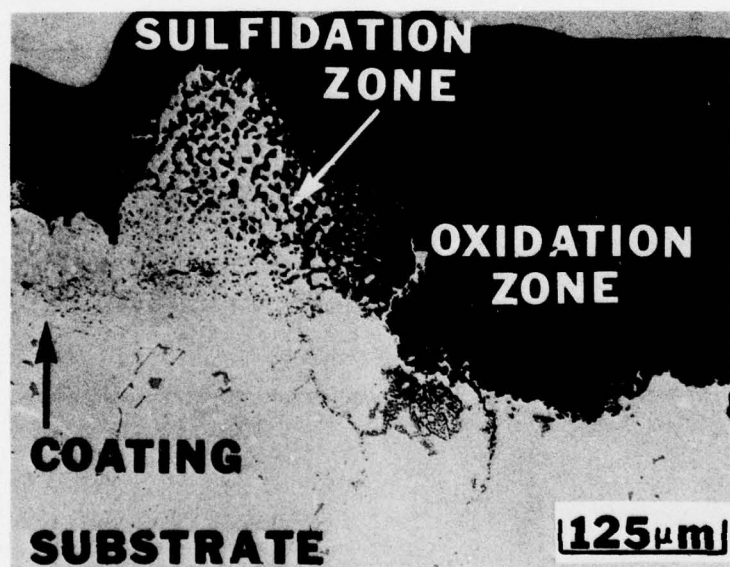
Figure 5. Additional photomicrographs showing typical microstructural features developed in engine operation of CoCrAlY-coated turbine blades: (a) oxidized leaders are sometimes associated with nodular attack, (b) cut-edge degradation may be observed at sites of coating penetration.

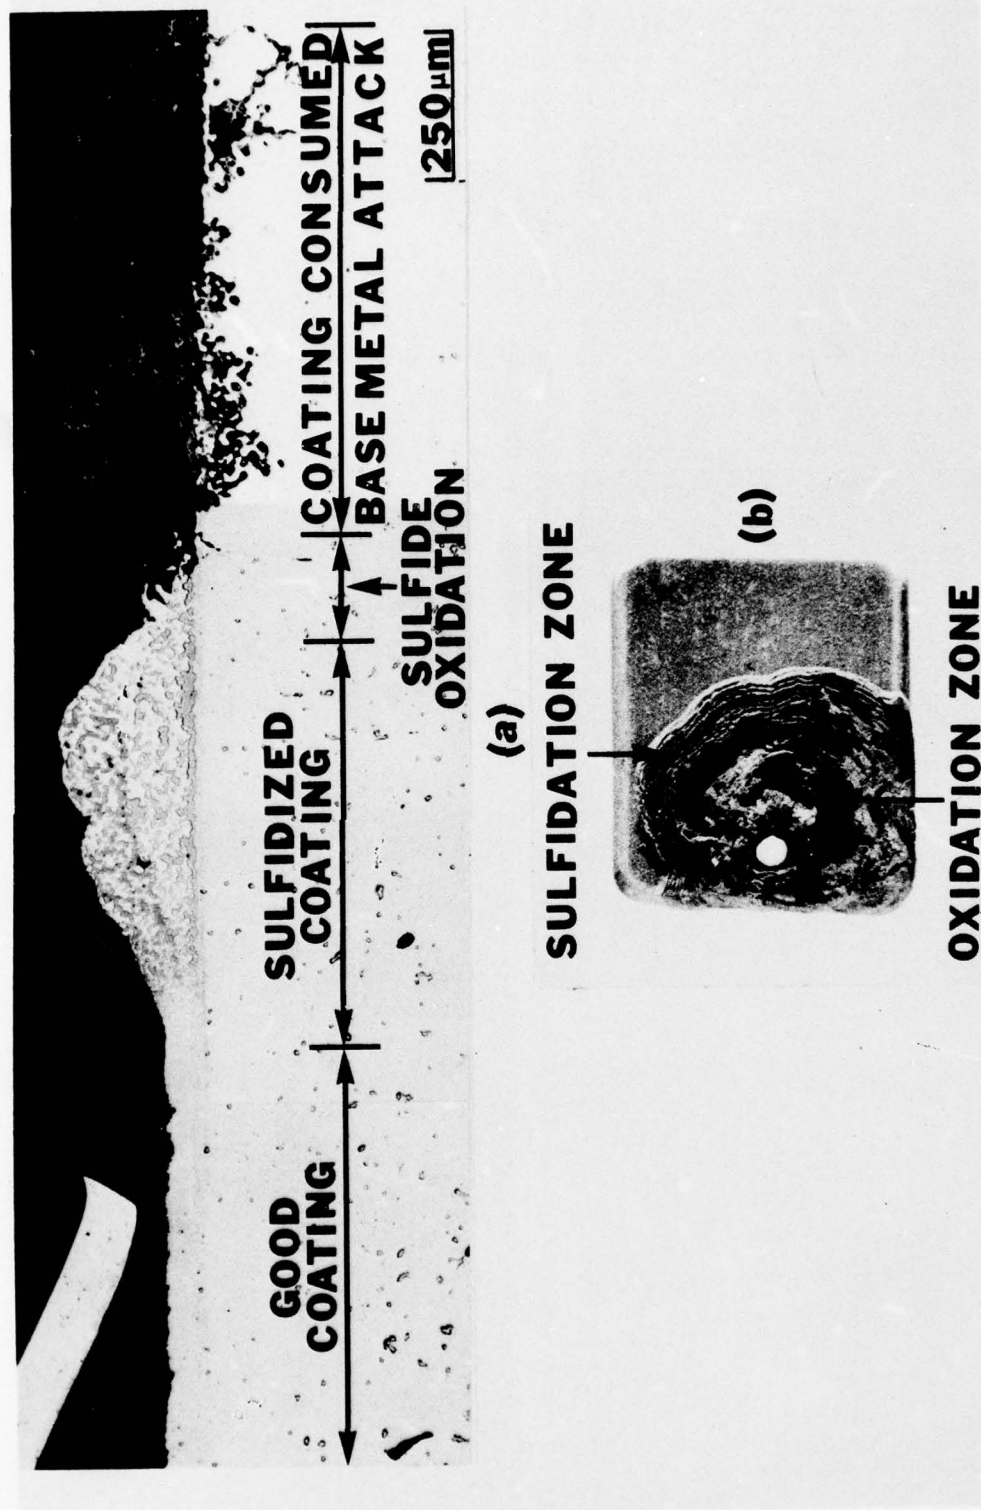
Figure 6. Cut-edge attack produced in furnace cyclic hot corrosion testing of diffusion aluminide coatings at 899°C: (a) microstructure of aluminized (PWA 73) IN 738 exposed 780 hours with  $\text{Na}_2\text{SO}_4$ , (b) macrograph of coupon of aluminized (LDC-2) MarM-200 exposed 380 hours with  $\text{Na}_2\text{SO}_4 + 2.5\% \text{V}_2\text{O}_5$ .

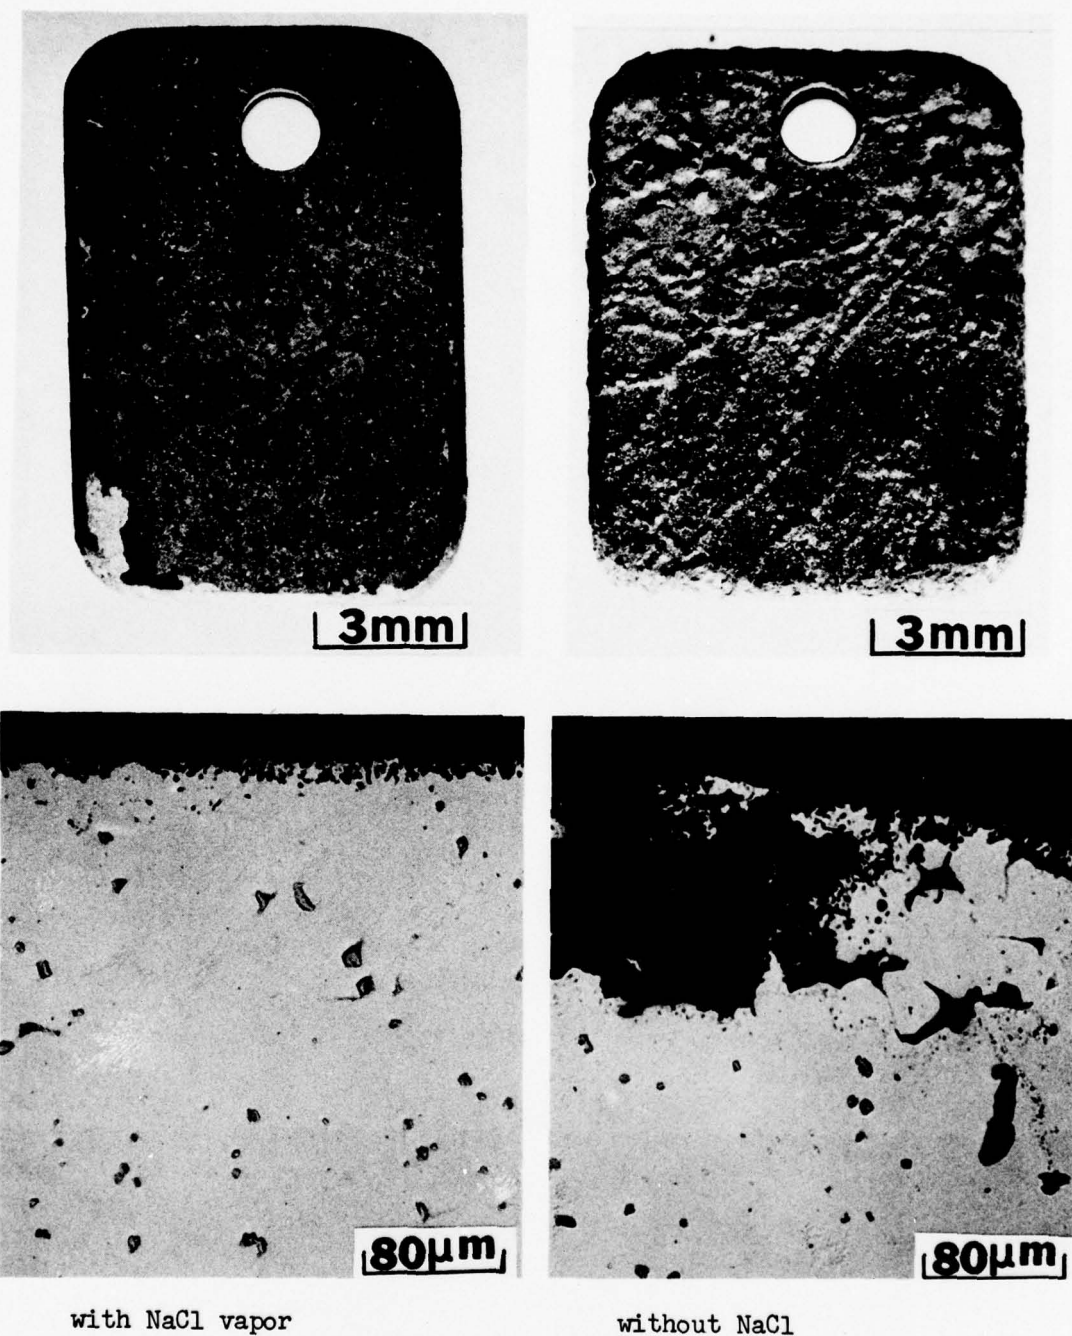
Figure 12. Surface condition and corresponding microstructures of uncoated IN 738 (Ni-16Cr-8.5Co-3.4Ti-3.4Al-1.75Mo-2.6W-1.75Ta-0.12Zr-0.85Nb-0.012B) after 300 hour hot corrosion test at 899°C (1650°F). Specimens were washed and recoated with 1 mg/cm<sup>2</sup> of Na<sub>2</sub>SO<sub>4</sub> every 20 hours. The specimen heated in air containing about 300 ppm NaCl vapor was less attacked than that exposed in chloride-free air.

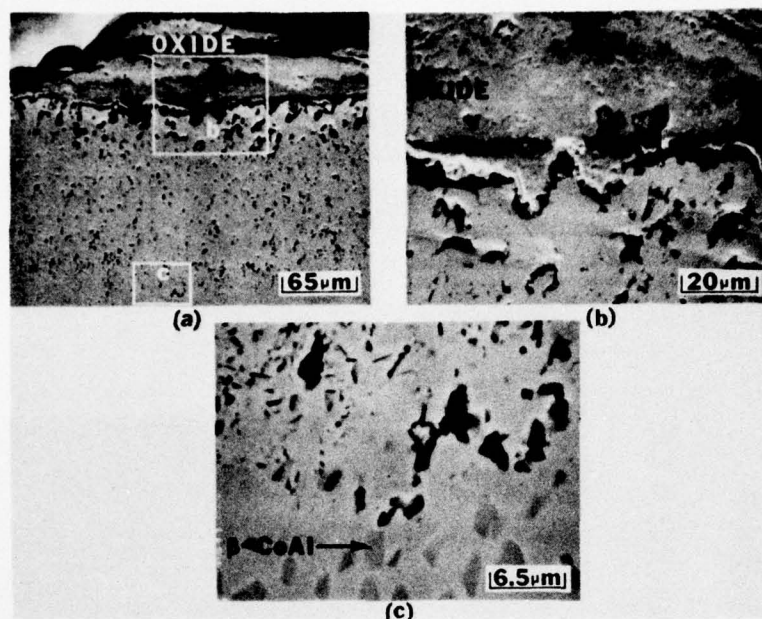
Figure 15. Cross sections through Co-25Cr-6Al-0.5Y after 100 hours in 899°C cyclic hot corrosion test with  $\text{Na}_2\text{SO}_4$  - 90% NaCl. Boxes in (a) are areas of X-ray images in Figure 16.

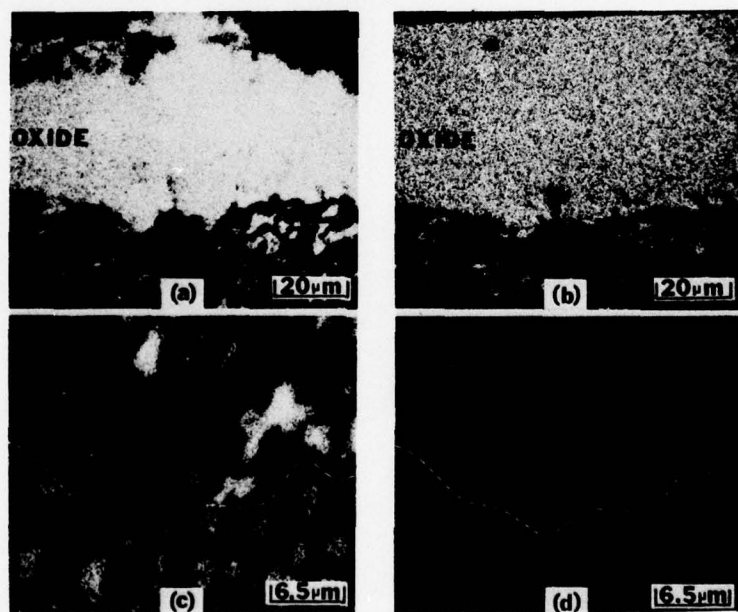
Figure 16. X-ray images of the specimen illustrated in Fig. 15; (a) and (c) are aluminum, (b) and (d) are oxygen. Dashed line in (c) and (d) is interface between innermost zone of internal attack and unaffected alloy. Al-rich areas in top half of (c) are believed to be Cl-containing pores.

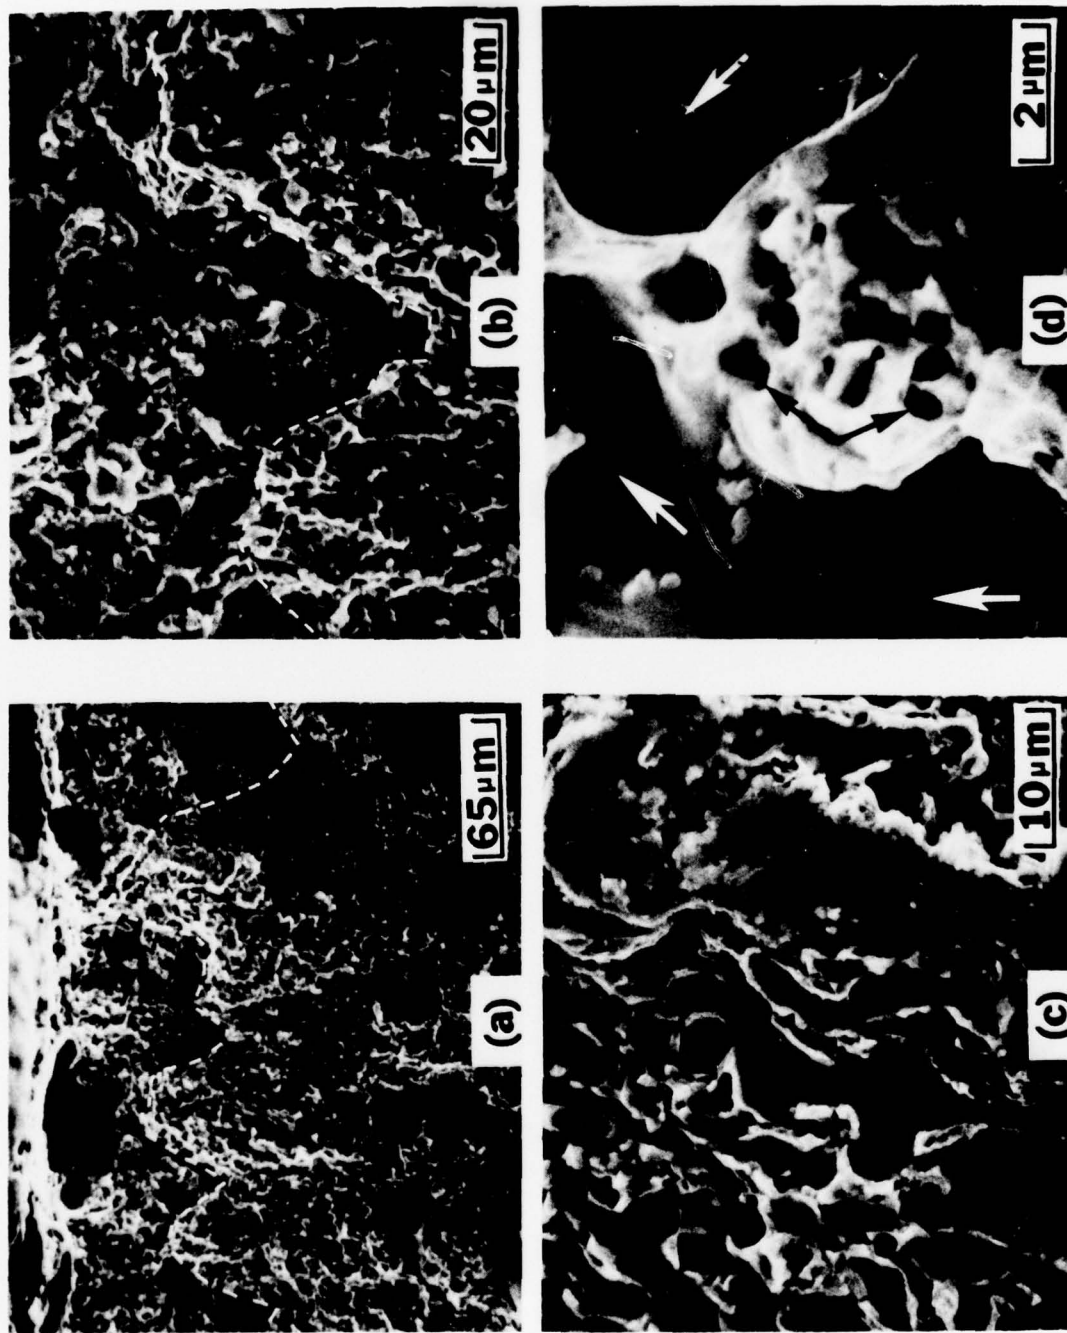
Figure 19. Scanning micrographs of fractured Co-25Cr-6Al-0.5Y specimen exposed 20 hours to cyclic hot corrosion at 899°C. Dashed lines in (a) and (b) mark extent of porous zone of internal attack. The pores appear to form a continuous network (c) which includes both large and very small pores (arrows in d).

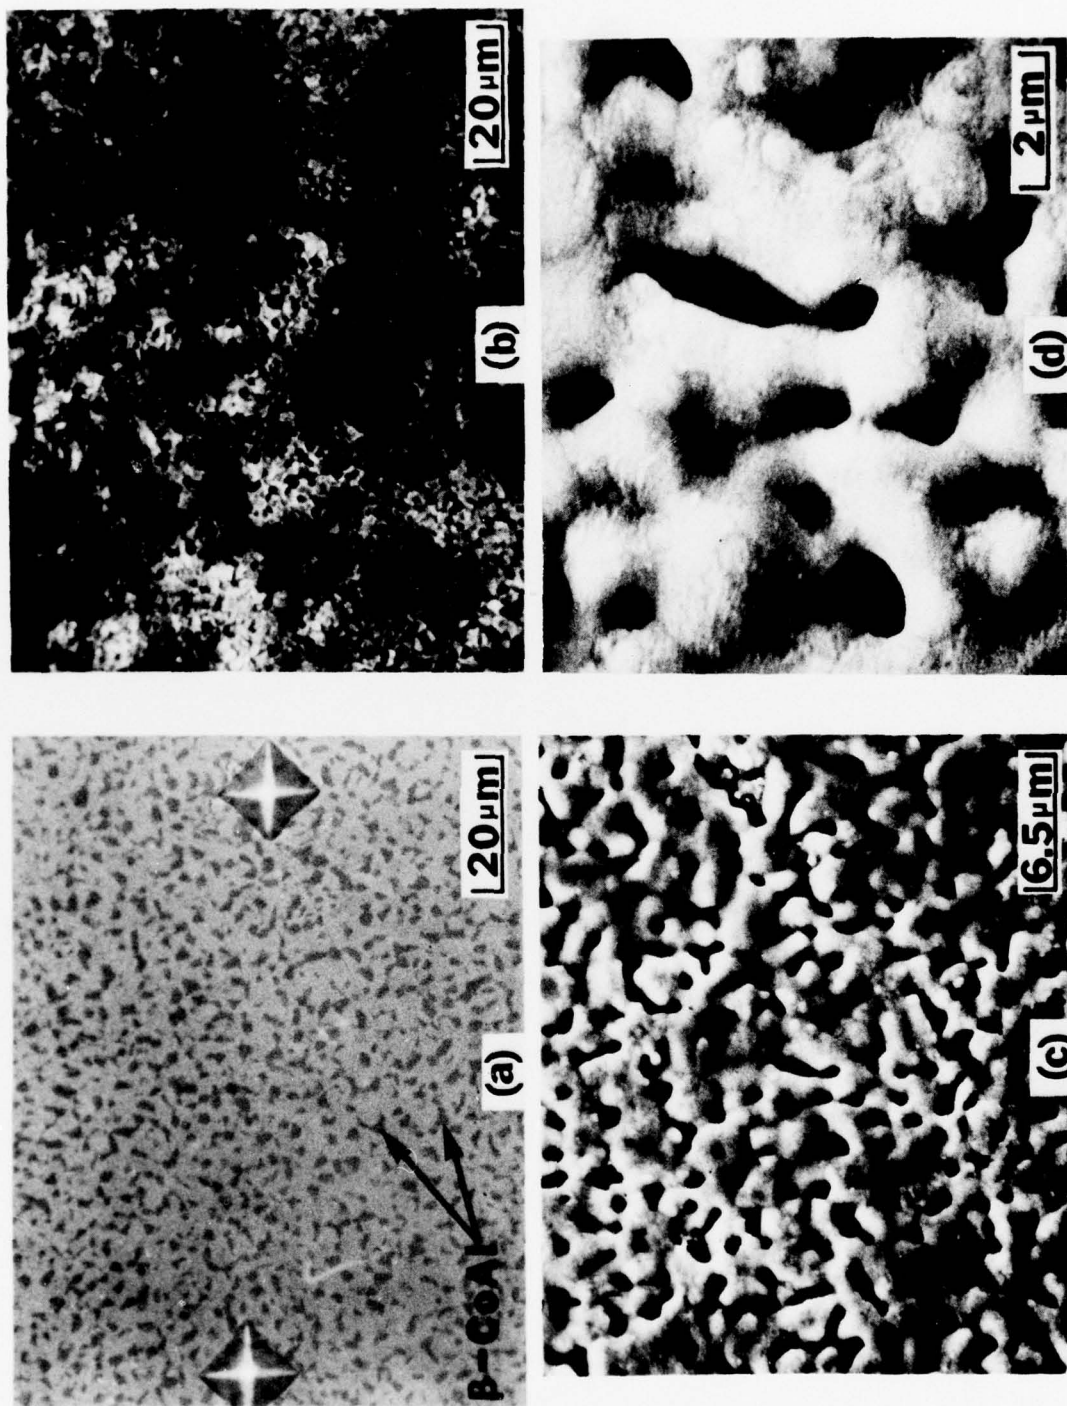
Figure 20. Pre-test polished surface and features developed in 10 minute exposure to  $\text{Na}_2\text{SO}_4$  - 90%NaCl at  $899^\circ\text{C}$ . Numerous pores are evident, the size and distribution of which are similar but not identical to the distribution of the  $\beta$ -CoAl phase in the pre-test microstructure.

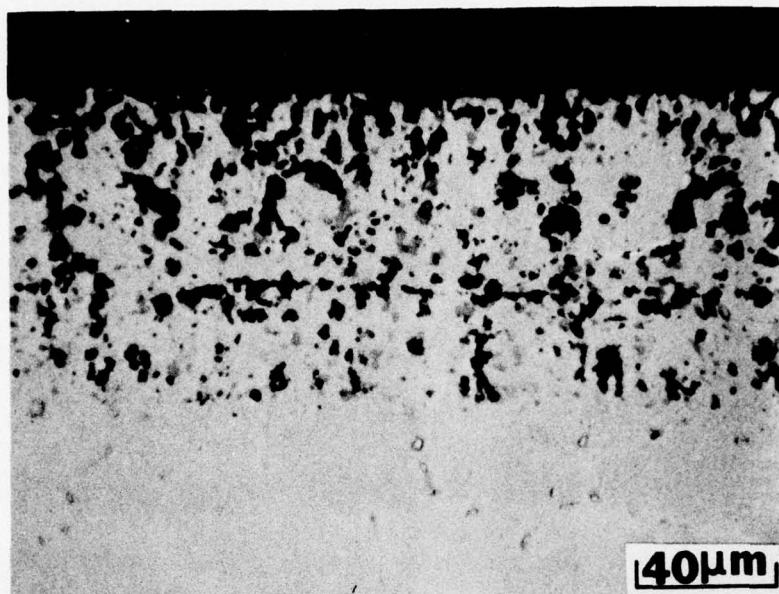
30a. Typical extent of dealloying and sulfide precipitation

Figure 30. Microstructure of LDC-2A platinum modified diffusion aluminide coating after 500 hours in the 899°C (1650°F) cyclic hot corrosion test with  $\text{Na}_2\text{SO}_4$  - 50% NaCl. Note different magnification of 30a and 30b.

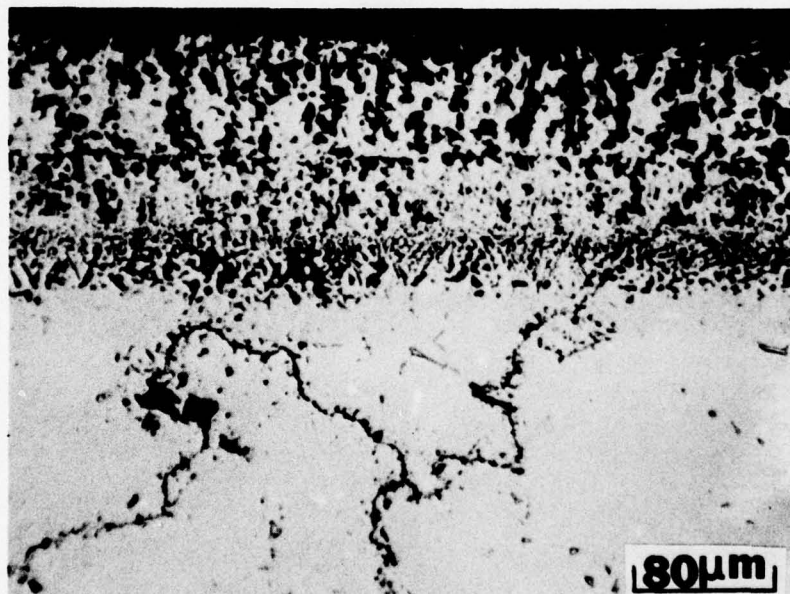
30b. Coating failure and substrate attack

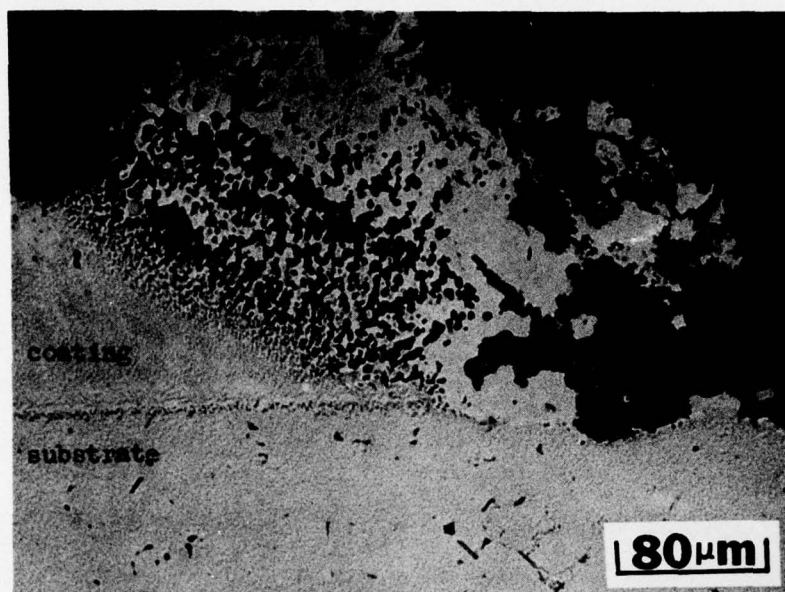
Figure 31a. Sidewise consumption of PWA 68 emanating from massive edge failure.

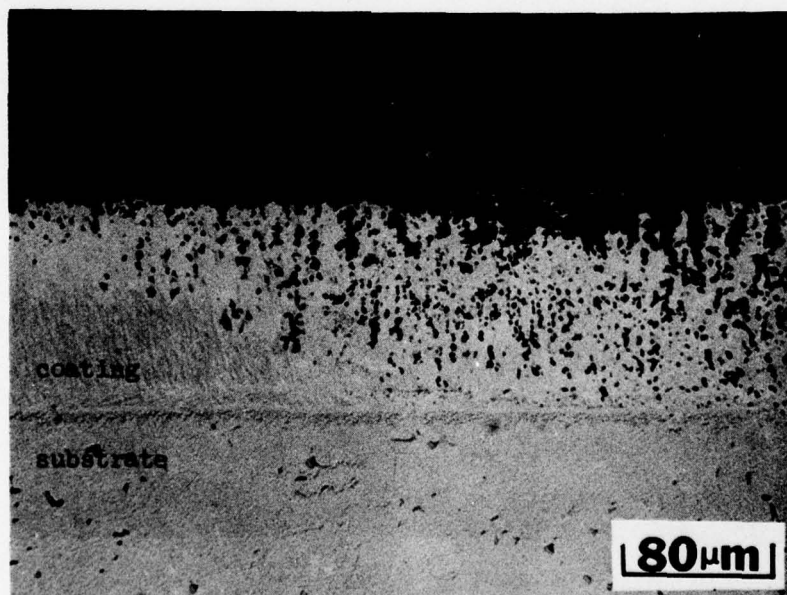
Figure 31b. Localized dealloying and internal oxidation of PWA 68, apparently the mechanism of coating penetration.

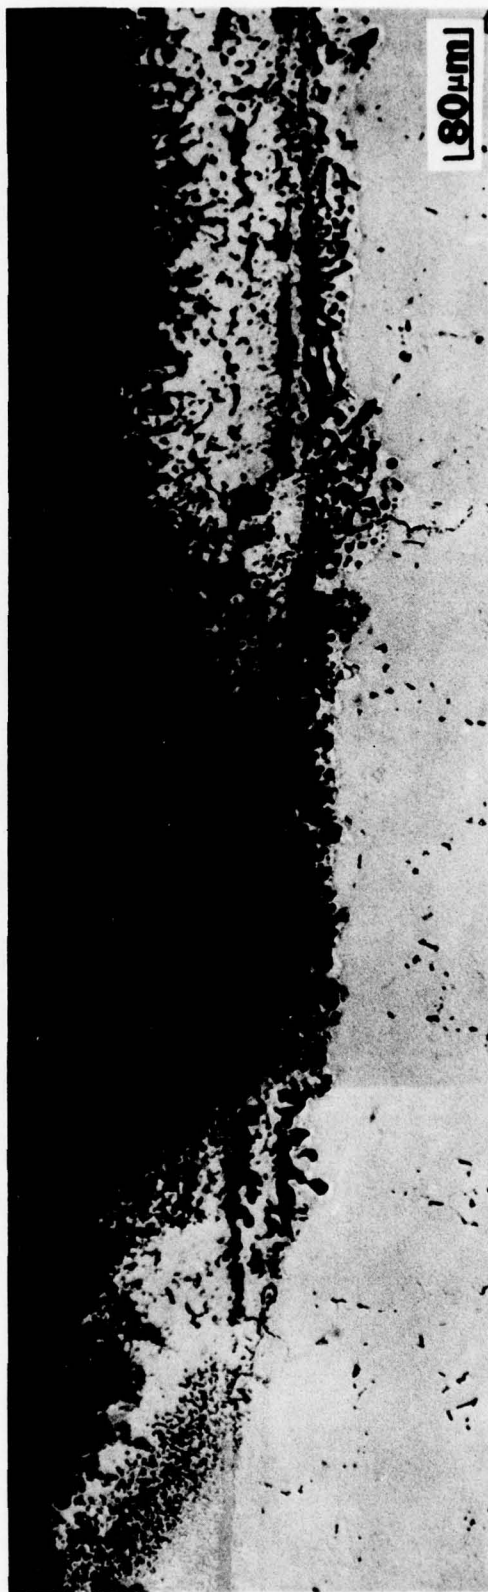
Figure 33. Penetration and cut-edge attack of Pt + FWA 68 coating. Features illustrated are typical of hot corrosion failure of CoCrAlY-type coatings, and Pt underlayer appears ineffective in modifying the mechanism or rate of sulfate-chloride degradation.

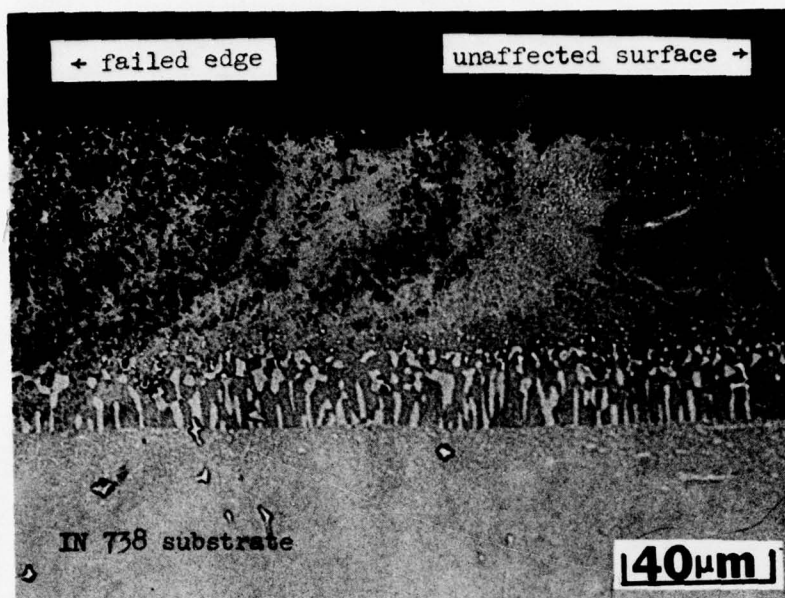
36a. Oxidation at edge of coupon

Figure 36. FWA 273 diffusion aluminide coating after 1000 hours in 649°C cyclic hot corrosion test with  $\text{Na}_2\text{SO}_4$  - 50%  $\text{NaCl}$ .

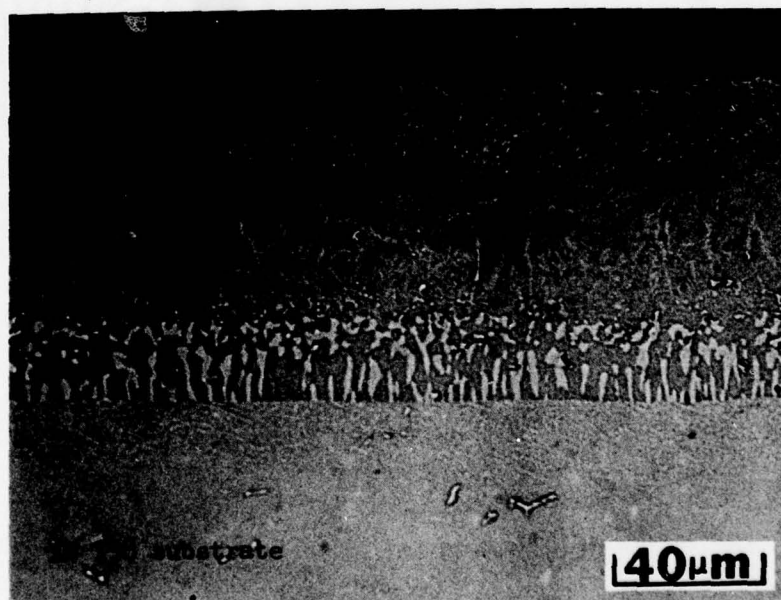
36b. Typical microstructure away from edge effect

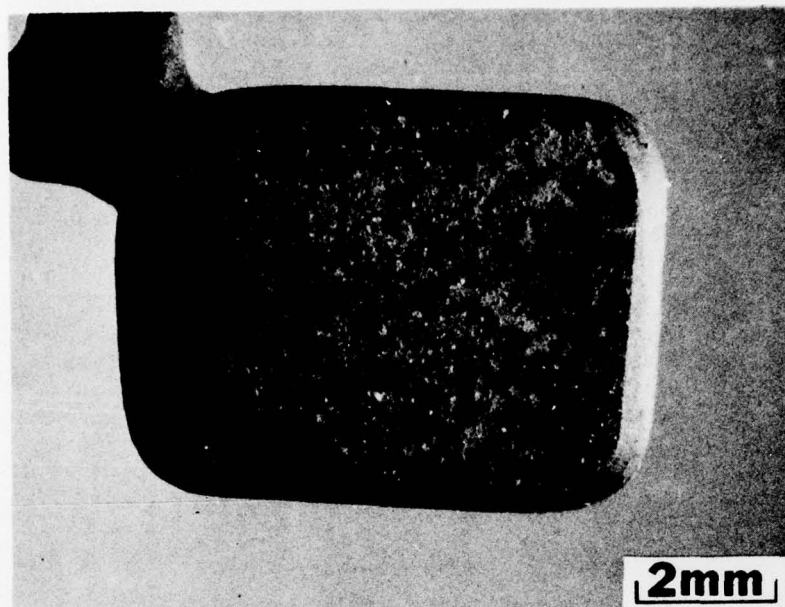
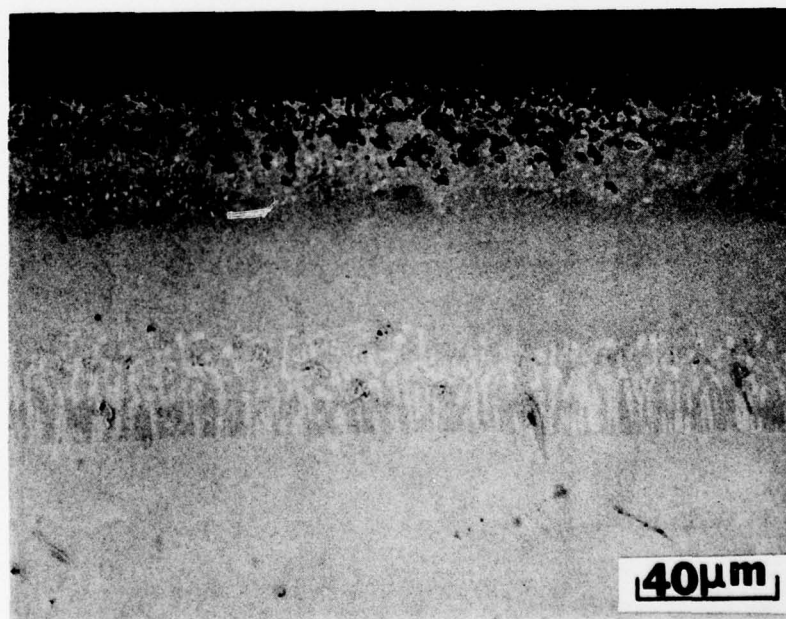
Figure 37. Surface degradation of PWA 273 diffusion aluminide coating after 2000 hours of cyclic hot corrosion testing at 649°C with  $\text{Na}_2\text{SO}_4$  - 50%NaCl salt.

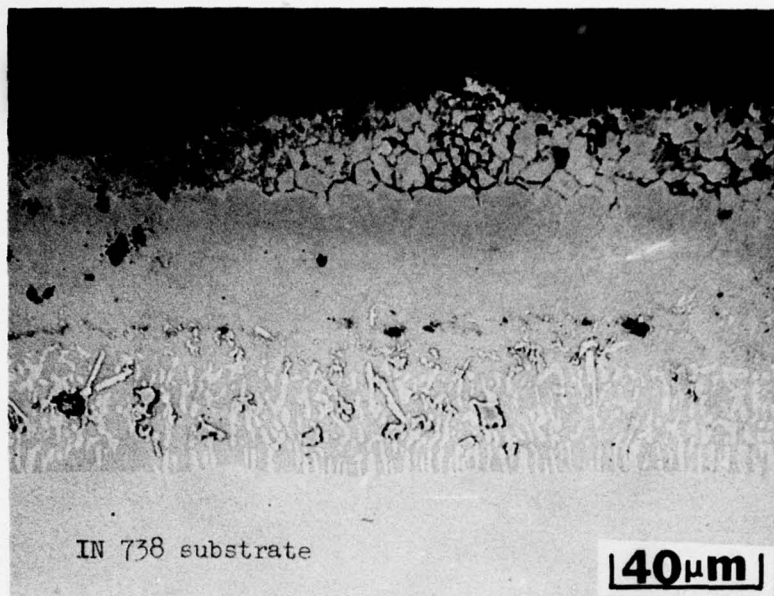
Figure 38. LDC-2A platinum modified diffusion aluminide. Surface microstructure was noticeably degraded in comparison with PWA 273, but there was no incidence of coating failure.

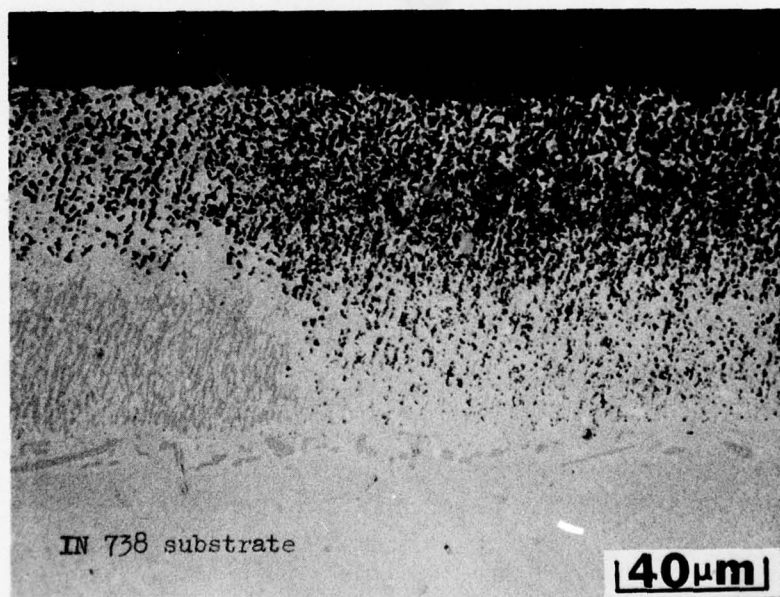
Figure 39. PWA 68 CoCrAlY after 1000 hours in 649°C cyclic hot corrosion showed general surface degradation and many areas of dealloying and precipitation of  $Al_2O_3$  through entire coating thickness.

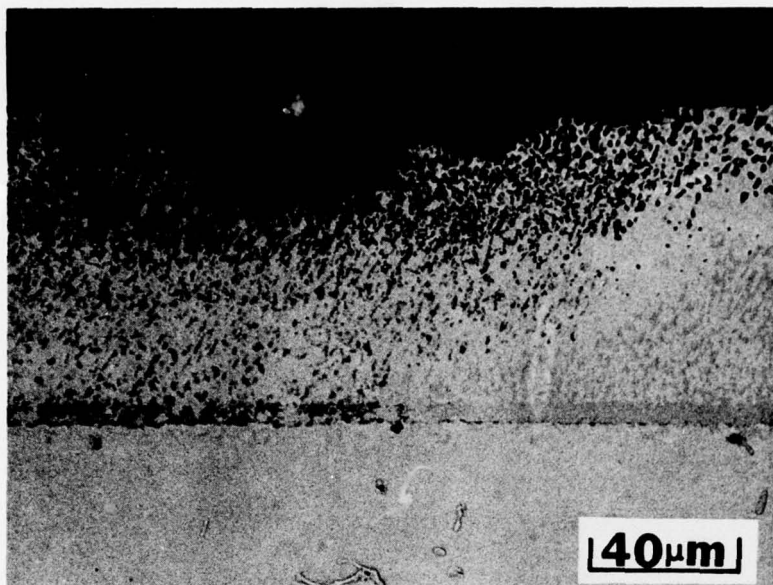
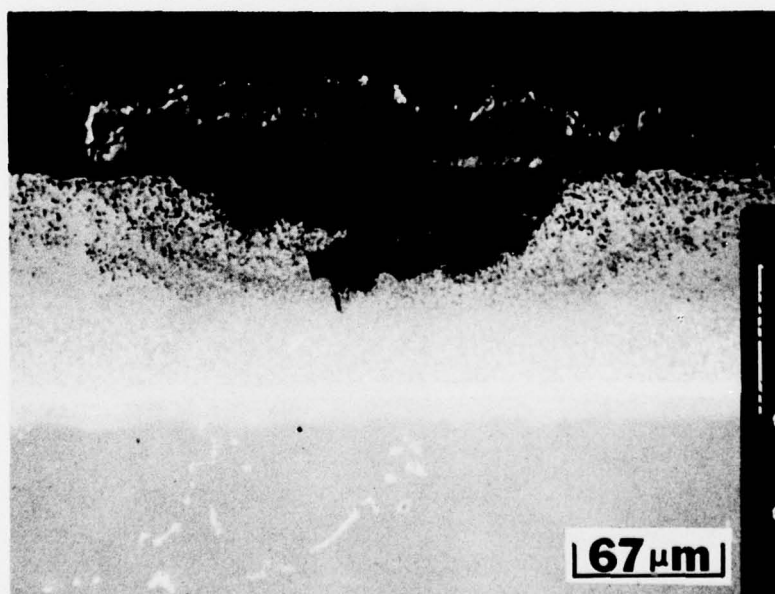
40a. 1000 hour coupon

40b. Back scattered electron image of coating protrusion shown in Fig. 41. (Platinum underlayer and Pt-containing diffusion zone appear white due to high average atomic number).

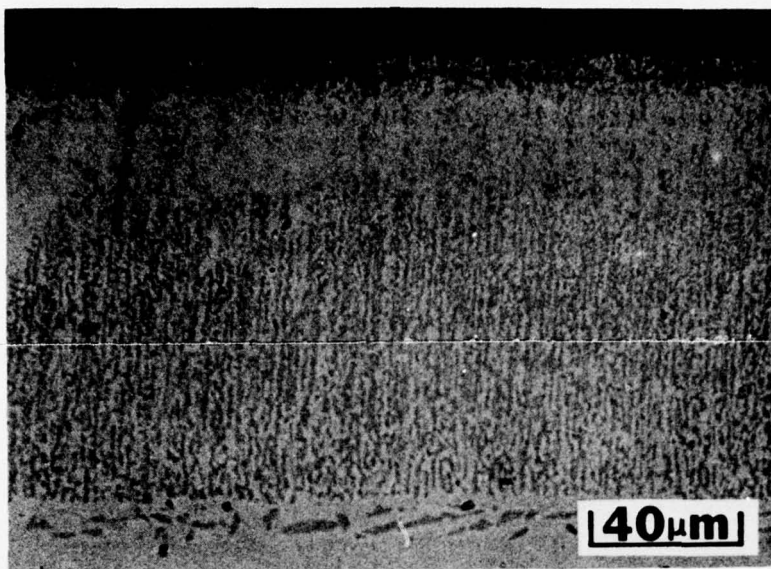
42a. PWA 68 coating with platinum overlayer suffered minimal degradation in 1000 hour cyclic hot corrosion test at 649°C. Microstructures shown in Figs. 39 and 40 were produced by the same exposure of PWA 68 without the platinum overlayer.

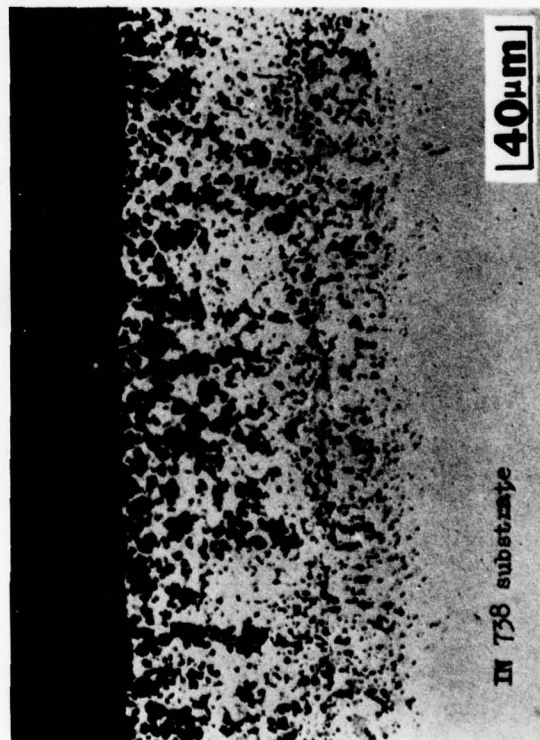
43c. Failed coating near edge

Figure 43. Surface condition and microstructure of PWA 73 diffusion aluminide coating after 120 hours in 899°C cyclic hot corrosion test with  $\text{Na}_2\text{SO}_4$  - 50% NaCl. Test was terminated due to general surface degradation and corner failure.

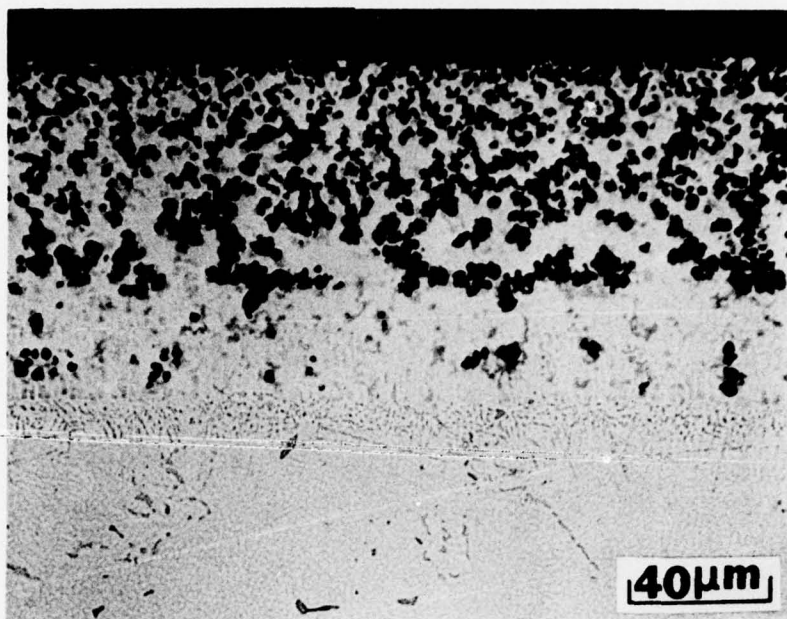
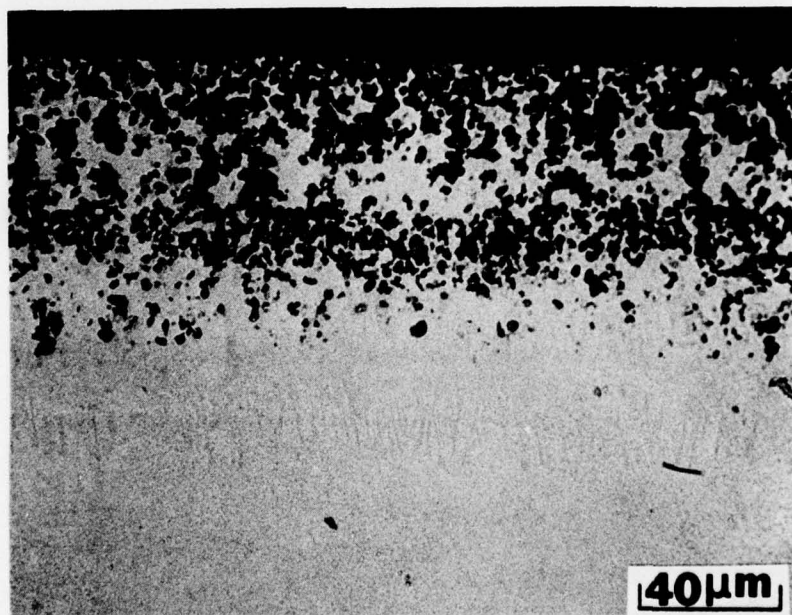
Figure 44. Microstructural degradation of PWA 273 diffusion aluminide coating in 899°C (1650°F) cyclic hot corrosion test with  $\text{Na}_2\text{SO}_4$  - 50% NaCl.

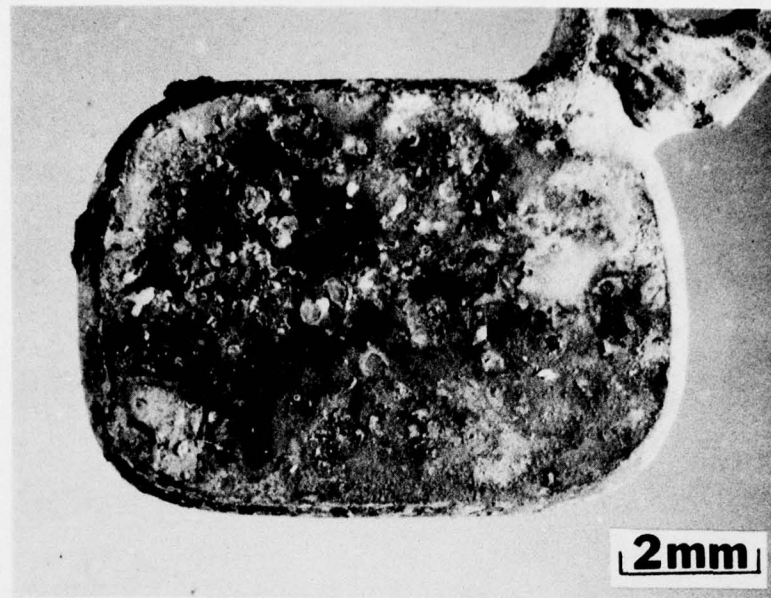
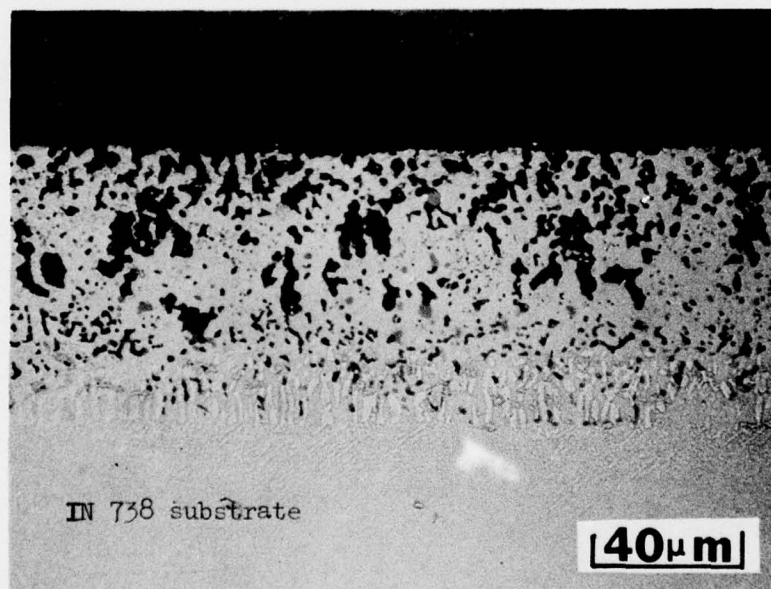
Figure 45. Surface condition and typical microstructure of chromized and aluminized (PWA 70 + PWA 73) IN 738 after 80 hours in  $849^{\circ}\text{C}$  cyclic hot corrosion test with  $\text{Na}_2\text{SO}_4$  - 50% NaCl.

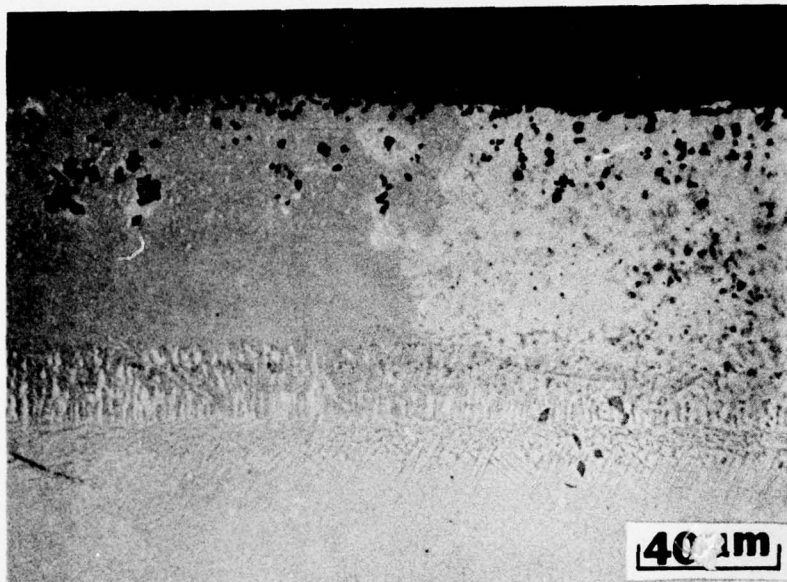
47a. Sharp transition in extent of dealloying

Figure 47. Variable microstructural degradation of sputtered Pt + PWA 273 coating in 1000 hour 899°C cyclic hot corrosion test.

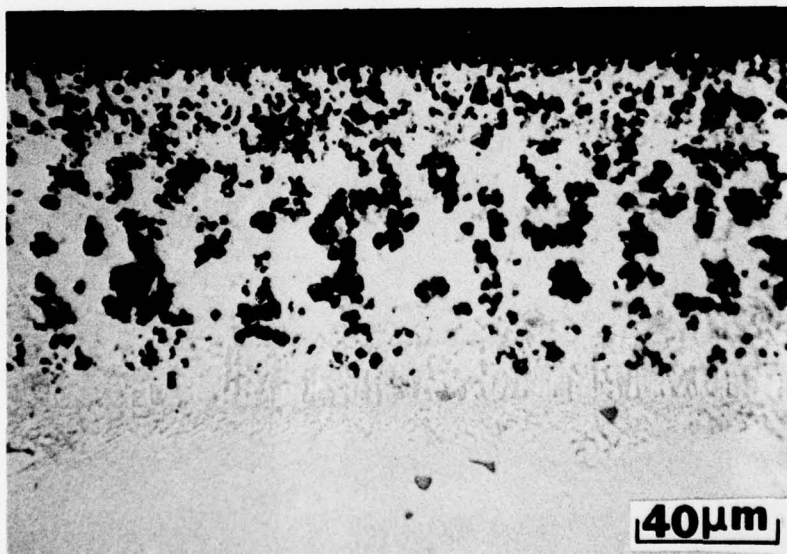
47b. Internal oxidation of entire coating thickness

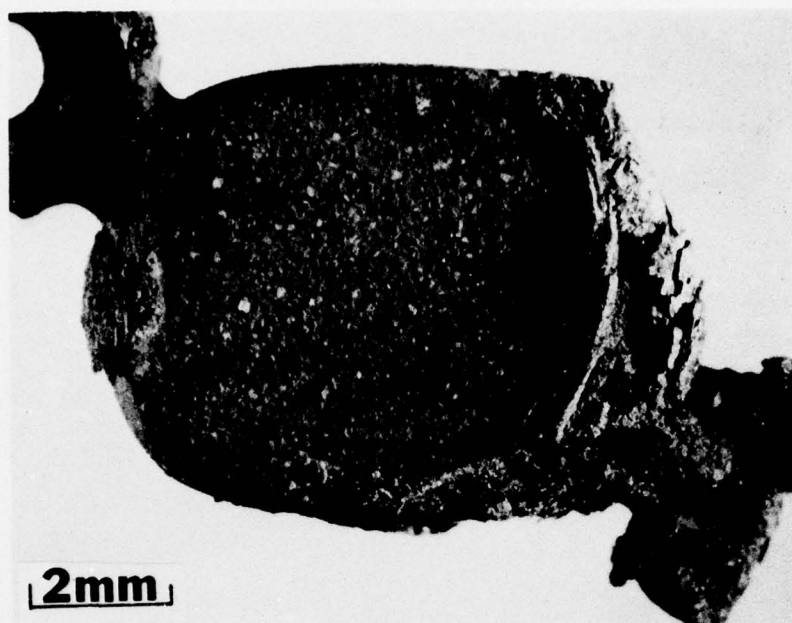
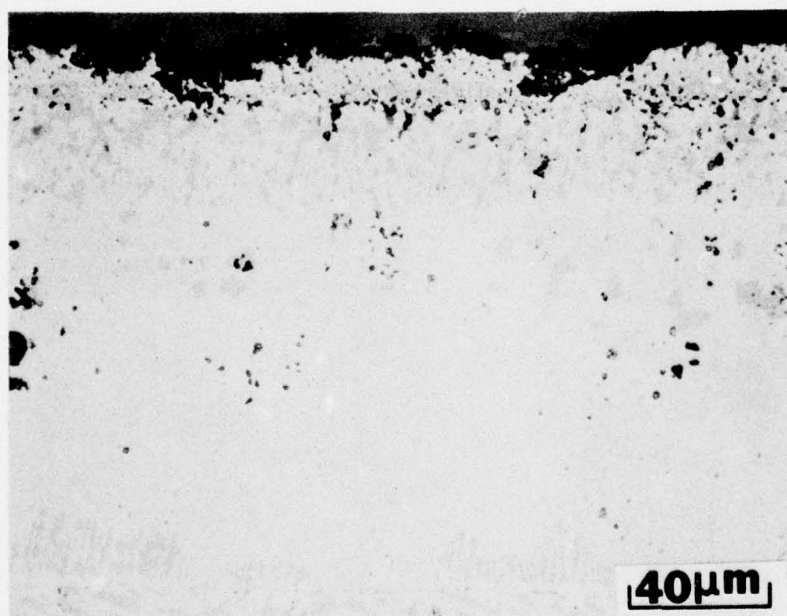
Figure 48. Surface condition and typical microstructure (away from cut edge attack) of PWA 68 coating with 6μm platinum overlayer; exposure time = 720 hours at 899°C.

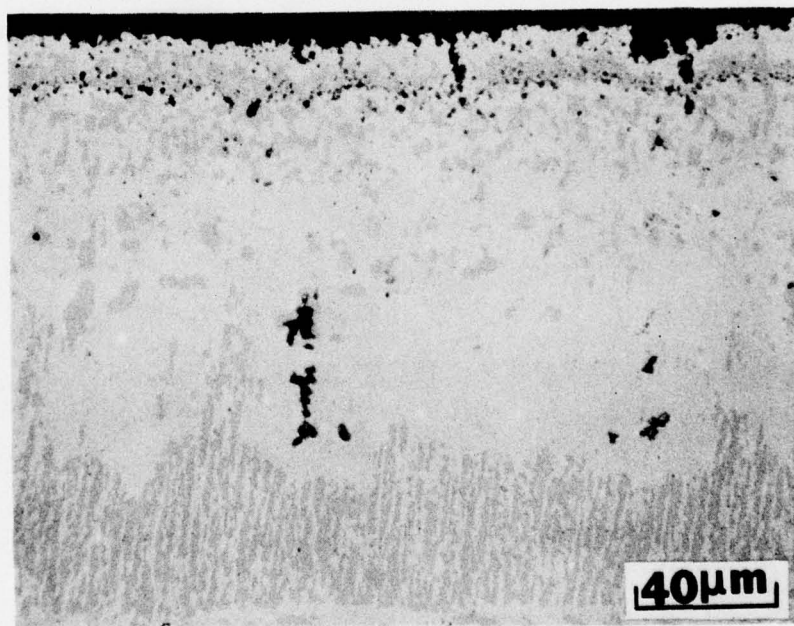
Figure 49. PWA 68 +  $\sim 12\mu\text{m}$  Pt overlayer; exposure time = 700 hours at  $899^{\circ}\text{C}$ . Thicker overlayer did not significantly improve performance (compare with Fig. 48).

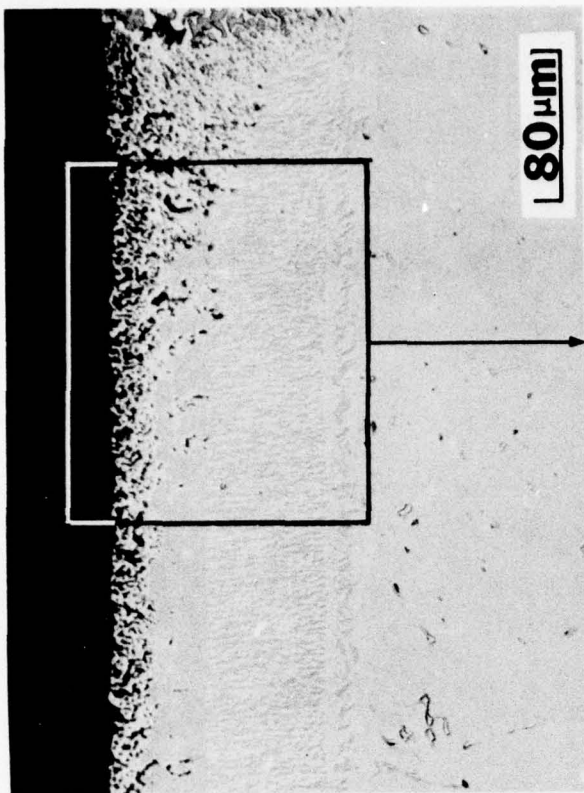
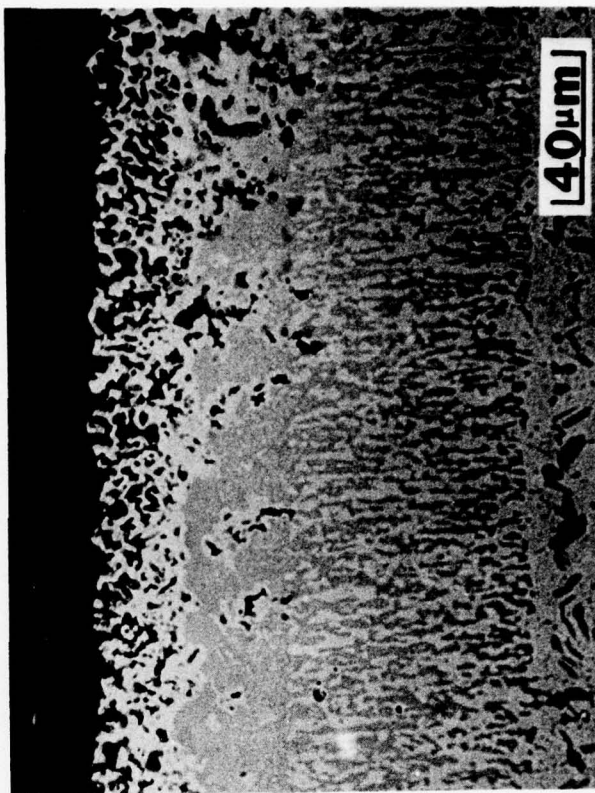
50b. Edge failure and uniform surface attack

Figure 50. Surface condition and microstructure of aluminized CoCrAlY (PWA 68 + PWA 273) after 80 hours in 899°C cyclic hot corrosion test with  $\text{Na}_2\text{SO}_4$  - 50% NaCl. Test was terminated due to edge failure.

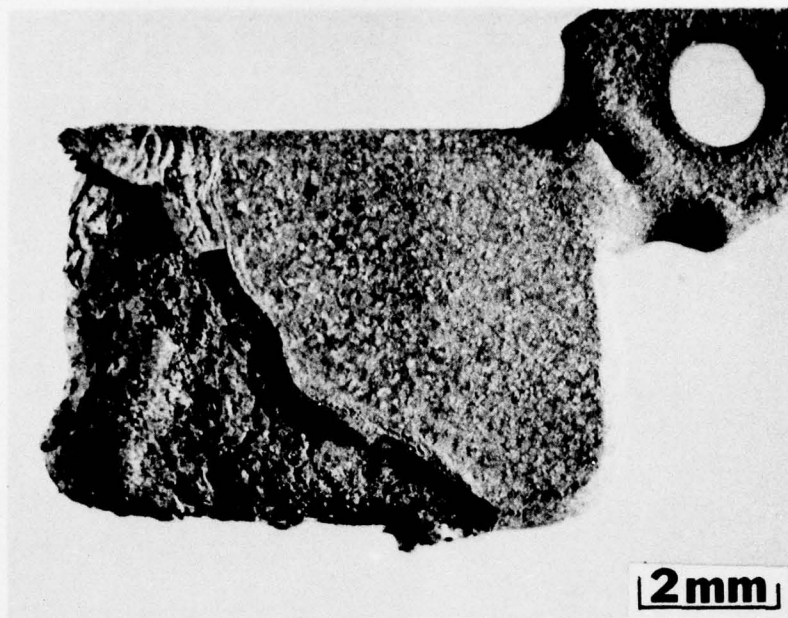
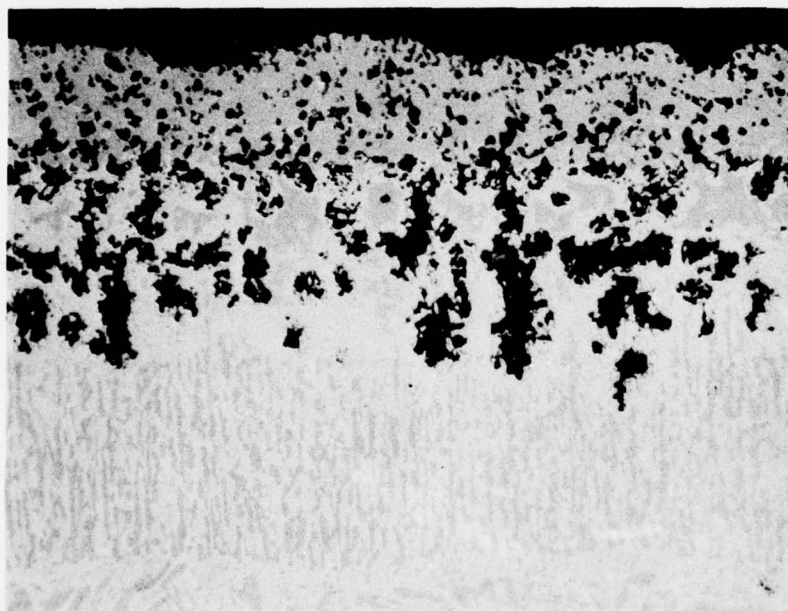
Figure 51. Surface condition and microstructural degradation (away from cut-edge effect) of PWA 68 + Pt overlayer + PWA 273 coating; exposure time = 520 hours in 899°C cyclic hot corrosion. Uniform depth of attack on other face of coupon was about half that shown in 51b.
